Virtex-II Pro PowerPC SEE Characterization Test Methods and Results

Abstract

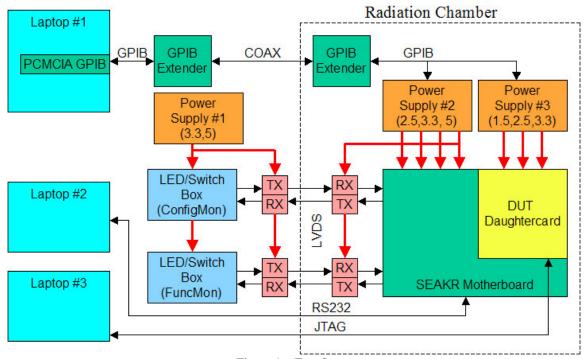
Figure 1 – Test Setup

The test instrumentation is illustrated in Figure 1. One laptop with a PCMCIA GPIB card serves to control the power supplies (Agilent 6623 and 6624) and record the voltage and currents for each DUT and motherboard power rail in strip-chart form using existing software [5]. GPIB extenders are used between the test chamber and user area. A second laptop is used to record all serial data received from the FuncMon UART. A third laptop is used for programming the DUT via JTAG. PowerPC information is also transmitted over this link upon request of the user. Due to incompatible software/firmware with the existing JPL counter boards, custom LED/Switch boxes, pictured in Figure 2, are used to provide control/status to the FuncMon and ConfigMon FPGAs on the SEAKR motherboard.

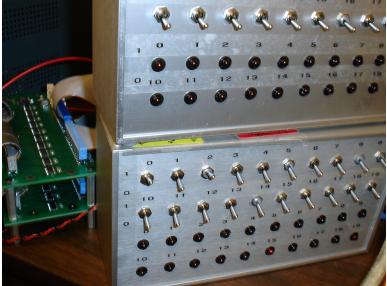
Figure 2 – FPGA LED/Switch Boxes

To run this test, the method communication needed to be solved without the aid of the JPL counter boards. Due to time constraints, a more manual, but effective approach was taken to give the user control over critical control signals and the ability to monitor the status of the FPGAs. Two identical control boxes (Figure 2) were built, one for FuncMon and one for ConfigMon. The control box consists of 20 toggle switches, 20 LEDs, and two 40-pin ribbon connectors. The connectors were designed to match the SEAKR motherboard IDE connectors (odd pins grounded). The switchconnector was cabled FuncMon/ConfigMon_In IDE connector on the SEAKR board. The FuncMon/ConfigMon_Out

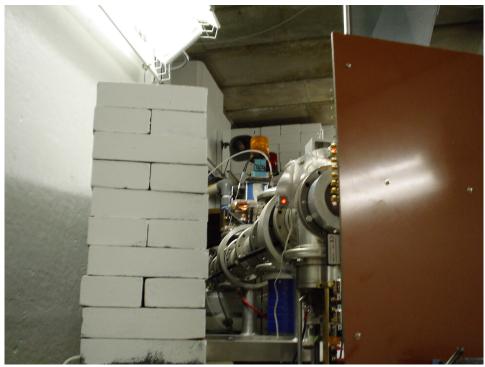
Figure 4 – XRTC V2Pro Board at IUCF Proton Beam

problem is discussed further in the Test Complications section. The cable distance from the beam-line to the user area is approximately 60 feet. Custom high-speed LVDS driver/receiver cards, pictured in Figure 3, are used to move data between the test chamber and user area over 40-pin twisted-pair ribbon cables. Figures 4, 5, and 6 show the board mounted vertically in the beam-line.

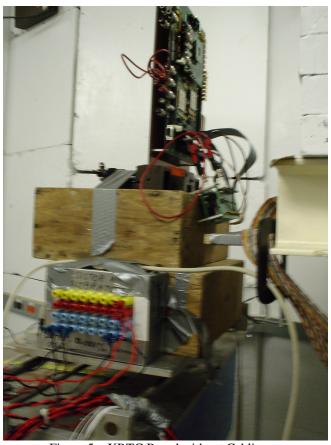
Figure 5 – XRTC Board without Cabling

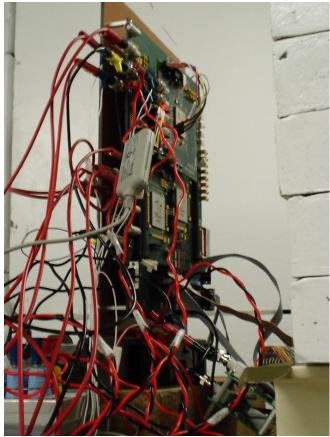
Figure 6 – XRTC V2Pro Board with Cabling

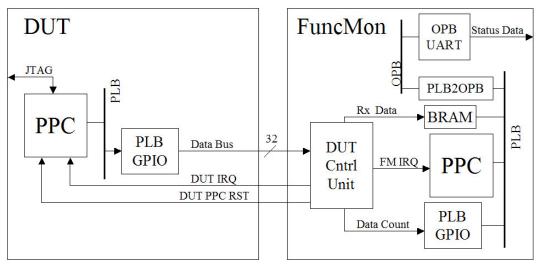
Figure 8 – Dynamic PowerPC Test Block Diagram

The purpose of this test application is to gather statistical data on how often the registers experience SEUs. In addition to controlling DUT resets, the FuncMon design includes a custom DUT_Control_Unit hardware core that periodically sends an interrupt to the DUT PowerPC core (IRQ frequency of 1-Hz). Upon receiving the interrupt, the DUT PowerPC proceeds to dump all register data (GPRs and SPRs) to the FuncMon using a processor local bus (PLB) GPIO data link. The FuncMon receives the data and stores the register value in BRAM and increments a counter. This is considered a "pseudo-static" test design, rather than a dynamic test design, since the DUT PowerPC runs minimal code during a test (less than 1% duty-cycle). Halted or corrupted data streams will identify the possibility of an instruction set upset, mishandled processor exception, processor reset, or other TBD SEFI. In order to minimize this occurrence, the assembly instruction set for the DUT PowerPC will be made as small as possible. A block diagram for this design is depicted in Figure 8.

Once the data transfer is complete, the FuncMon PowerPC will receive an interrupt from the DUT_Control_Unit. The FuncMon PowerPC will then dump all recorded data to the UART port. Each data dump will be timetagged. Logging the SPR data may provide insight as to how the PowerPC is affected by SEUs.

The clocking is derived using a DCM within the FuncMon FPGA. The ConfigMon FPGA supplies the FuncMon with a 33 MHz clock. The DCM performs a 2x and 4x operation, yielding two clock speeds of 66 MHz and 132 MHz. The DUT FPGA logic, DUT PowerPC, and FuncMon FPGA logic all operate at 66 MHz. The FuncMon PowerPC operates at 132 MHz.
